RAILROAD COMMISSION OF TEXAS

RE: Weesatche Project, Goliad County
Uranium Exploration Permit No. 123B
Inspection Report

URANIUM EXPLORATION INSPECTION REPORT

Project Name: Weesatche Permit Number: 123B

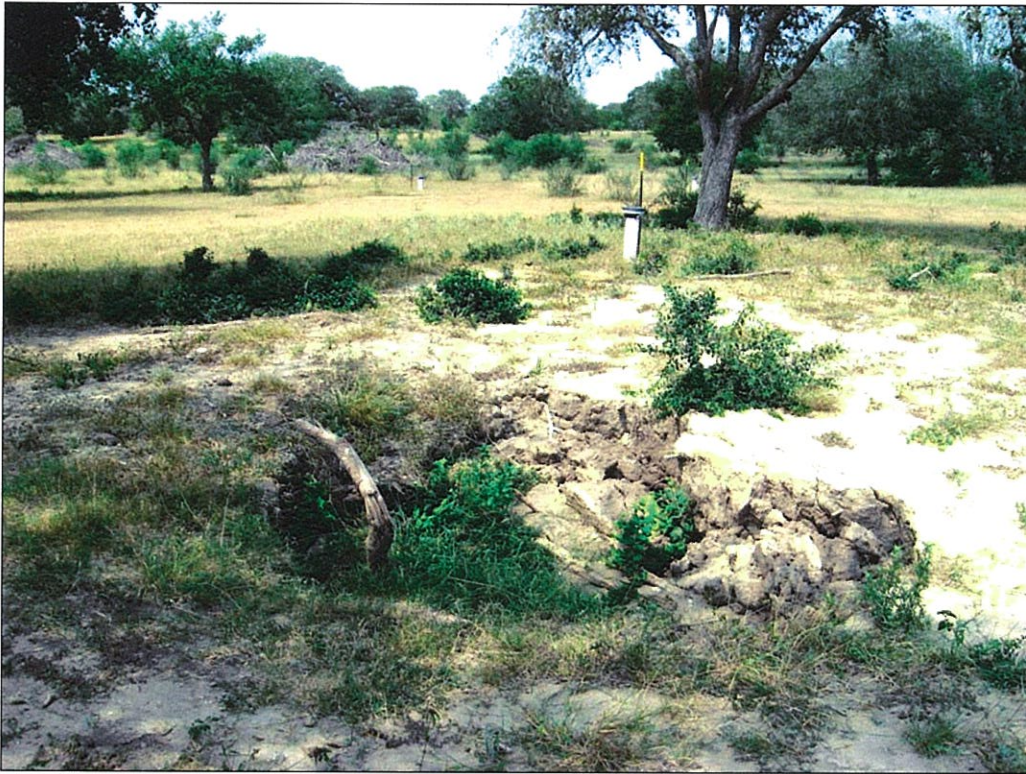
This inspection of UEC Permit No. 123 focused on site restoration follow up on the Braquet section of the permitted exploration area. A subsided mud pit was located near an array of cased wells, as documented in Photo 1, pointing out the need for on-going monitoring of mud pits for this type problem as this area had been examined relatively recently with no subsidence noted. Numerous cased well and exploration borehole locations were examined with no further evidence of subsidence issues. Examples of typical site restoration efforts around cased wells are documented in Photos 2-3, where the cased wells were found to be properly secured with the casing capped or flanged closed with locks in many cases. The area surrounding the un-inhabited houses on the Braquet property was inspected as there were numerous drilling locations in close proximity to these structures as seen in Photos 4-5. Little evidence of exploration activity was currently visible near the houses during a circle of the area as documented in Photo 6. A field with numerous exploration boreholes to the north of the Ander church and cemetery was inspected on 5-21-08 and a typical example of the site restoration efforts at that time of borehole N-16 is seen in Photo 7. There remains little evidence of exploration activity in this field as documented in Photo 8 in which the church and cemetery are clearly visible. Despite the near 3 inches of rain noted during the May inspection at Permit No. 123, persistent drought conditions continue to hamper re-vegetation as seen in Photos 8-10. The drilling locations of boreholes N-255 and CC-4 were well vegetated on 7-16-08 but are seen to be significantly less so currently.

Photo 1: Subsided mud pit near cased well on Braquet lease.

UEC representative James Gale stated that the subsided mud pit noted would be attended to as soon as possible and other areas examined for other instances of this type.

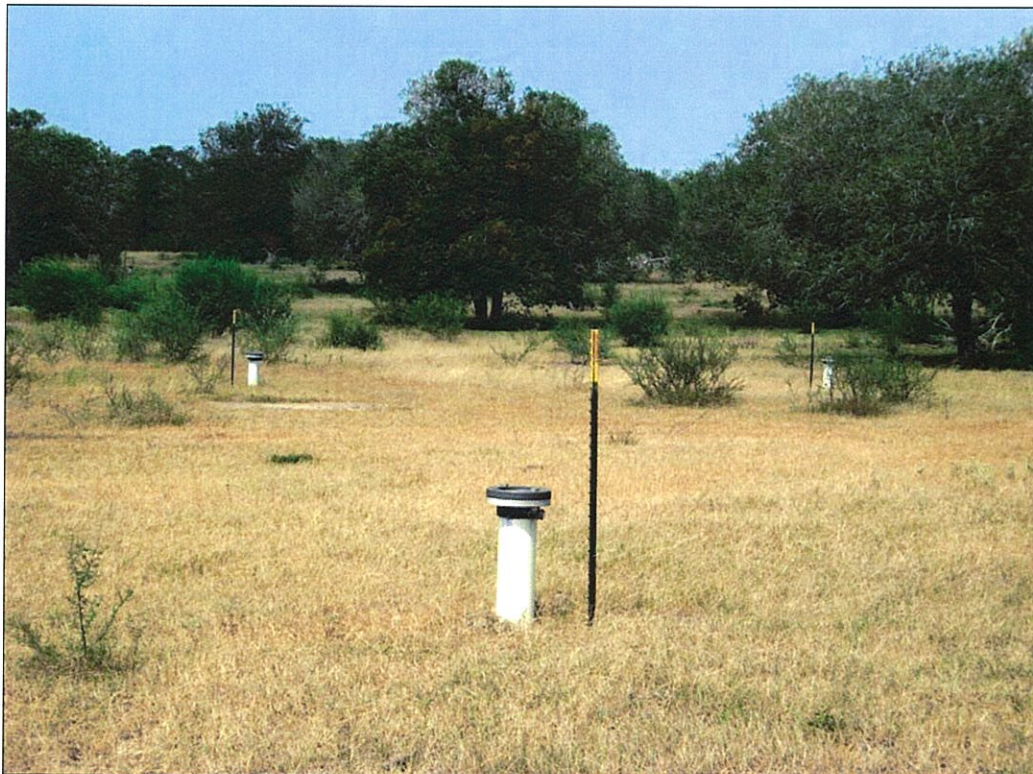
Photo 2: Site restoration of cased wells on Braquet property.

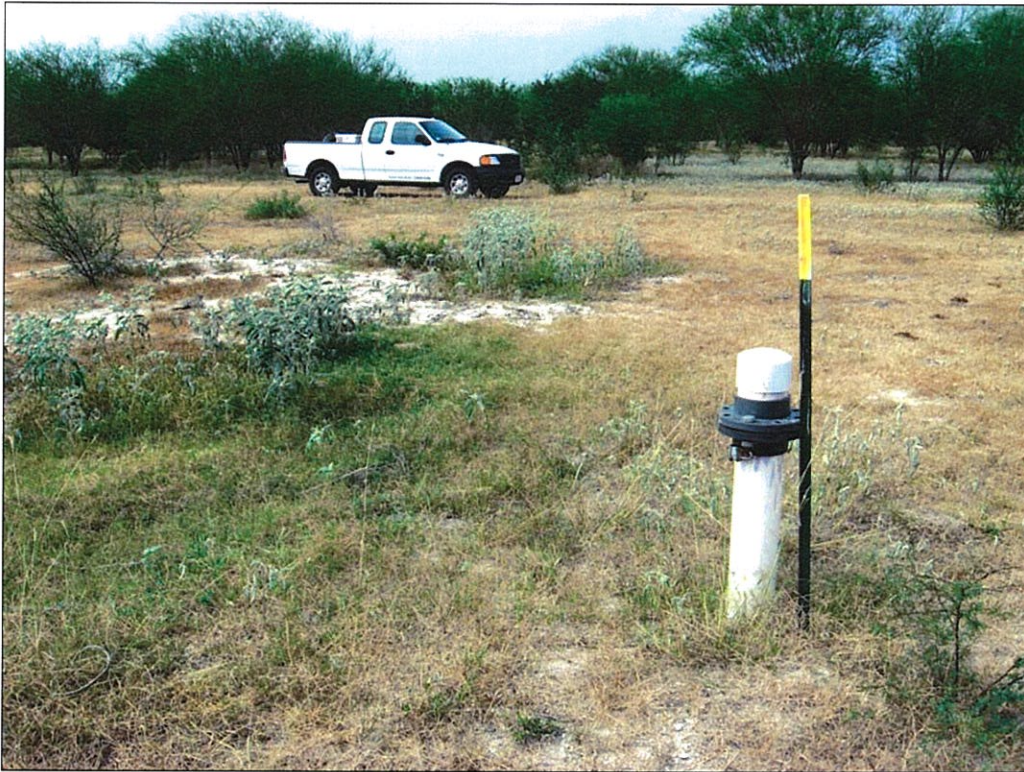
Photo 3: Cased well properly secured with cap locked on.

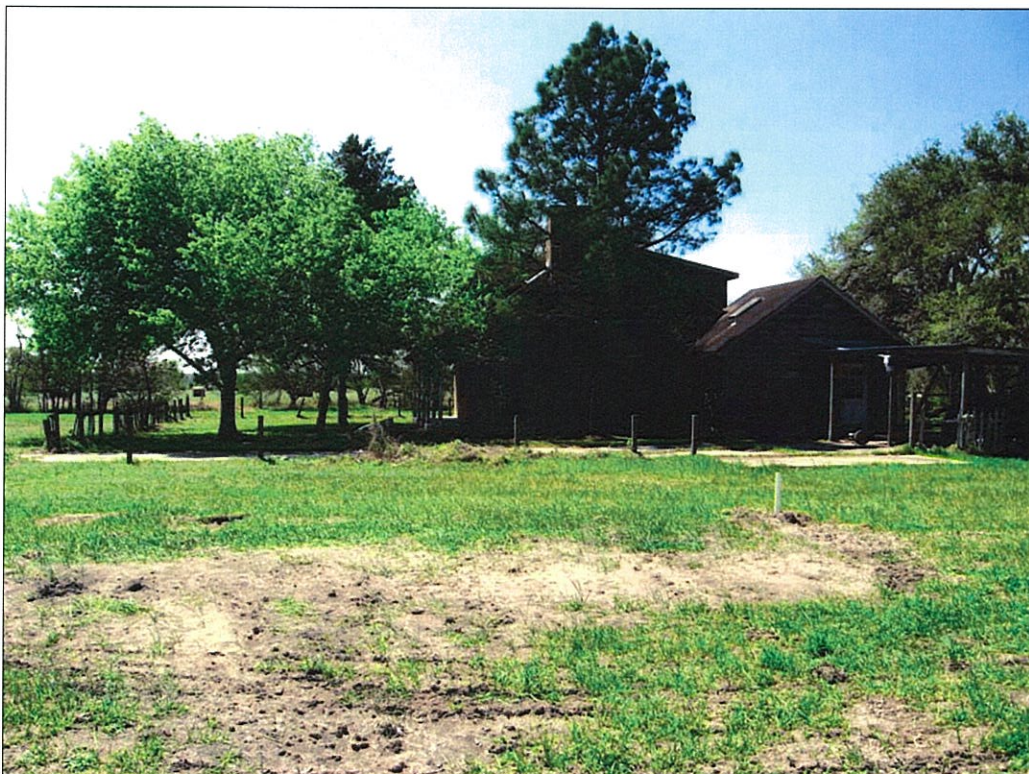
Photo 3: Exploration drilling location near old house on Braquet lease on 3-19-08.

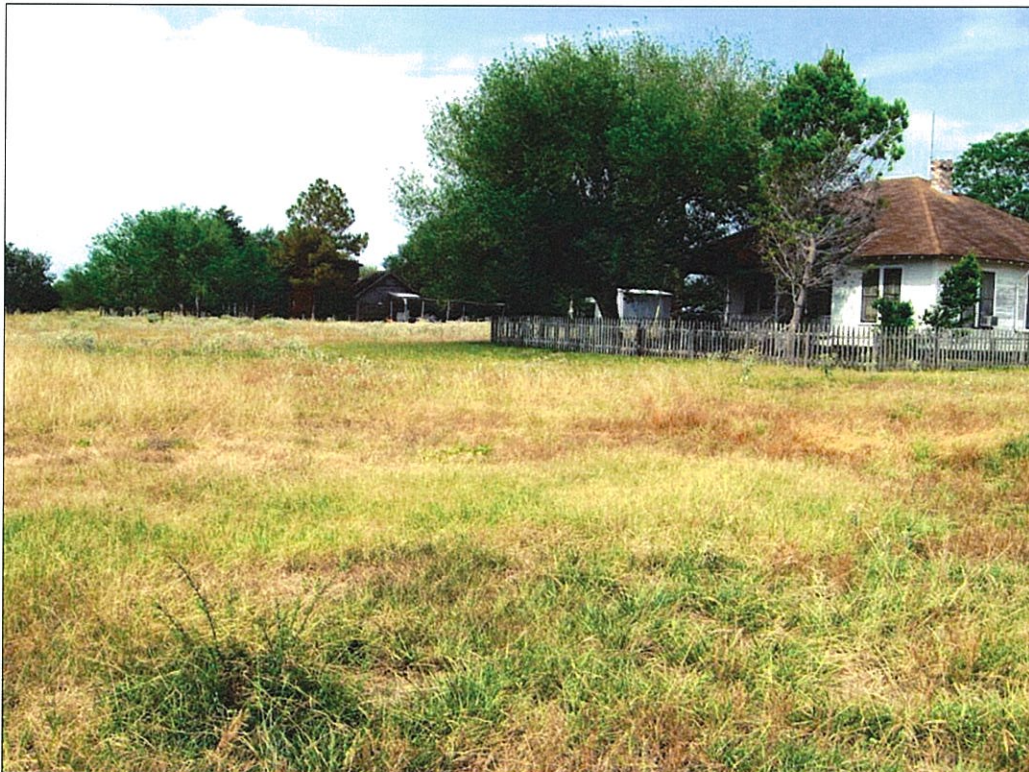
Photo 5: Houses on Braquet property with little evidence of exploration activity on 6-25-09.

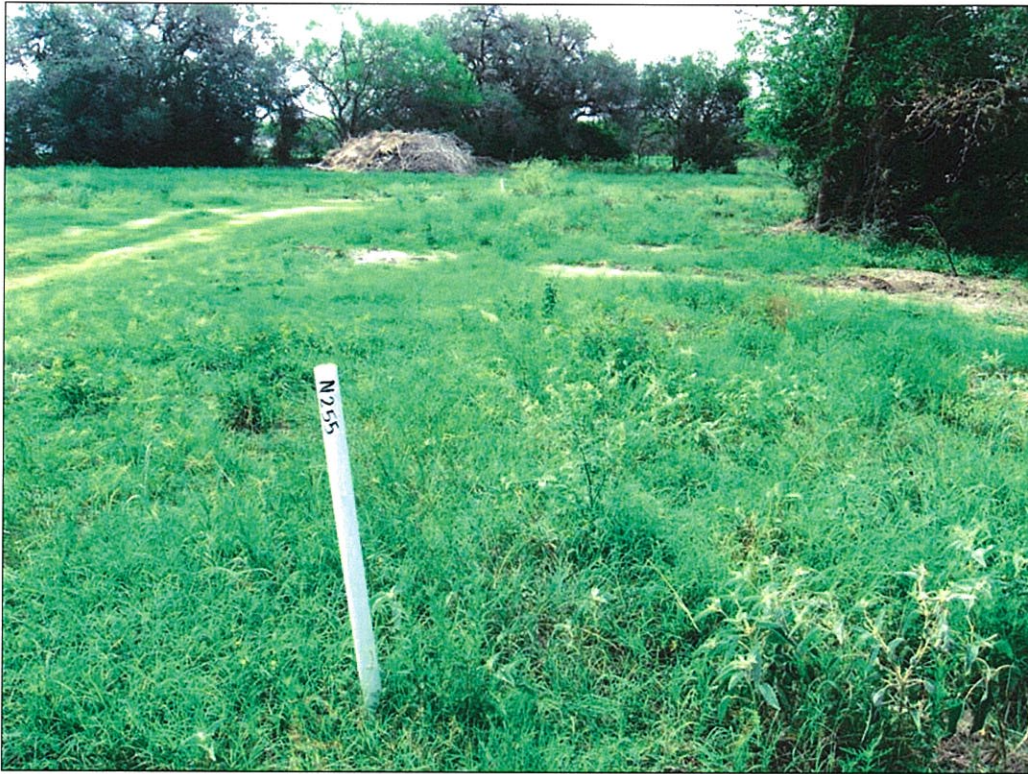
Photo 8: Boreholes N-255 and CC-4 on 7-16-08.
